## Wyckoff Sheet Pile Wall – Thickness Testing, 2017

PREPARED FOR: Helen Botcher/EPA  
PREPARED BY: Jerry Duppong/SEA  
Ken Scheffler/SEA  
DATE: October 13, 2017  
PROJECT NUMBER: 666966.ET.17.02

This memorandum summarizes thickness measurements of the sheet pile wall at the Wyckoff facility on Bainbridge Island, Washington. The field tests were performed on May 24, 2017.

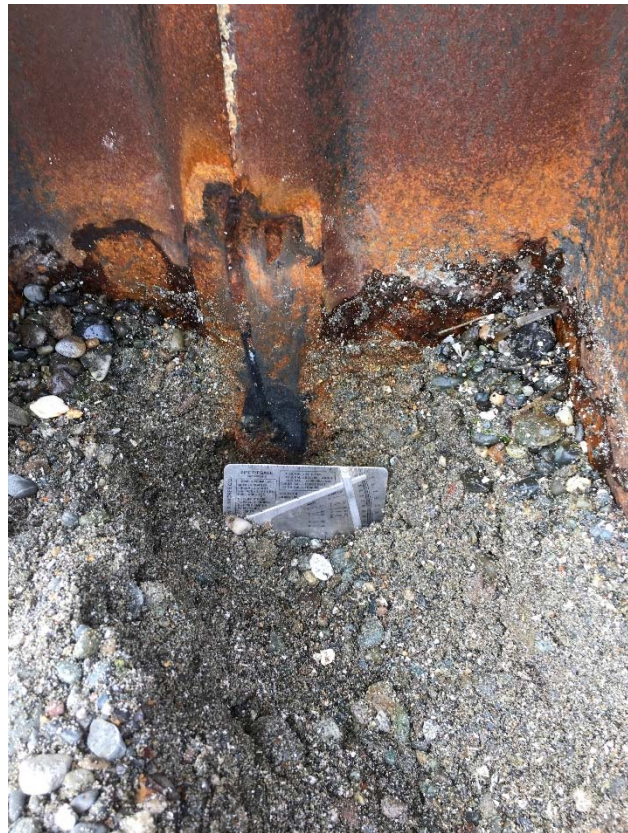
The general appearance of the sheet pile wall was similar to that observed in 2013, with one significant difference. The interlocks along the interior faces of the piles have significant loss of metal at the mud line (see adjacent photograph). The deterioration is very localized at the interior face interlock; no significant deterioration was noted on the pile surfaces adjacent to the interlock or on the interlock surfaces located along the exterior faces of the piles. The deterioration of interlocks appears to be most significant along the east wall. Although no obvious cause of the deterioration was identified, it is possible that the metal loss in this area is being caused by stones and gravels that are pushed against the joint by wave actions.

*Corrosion of interlocks at mudline.*

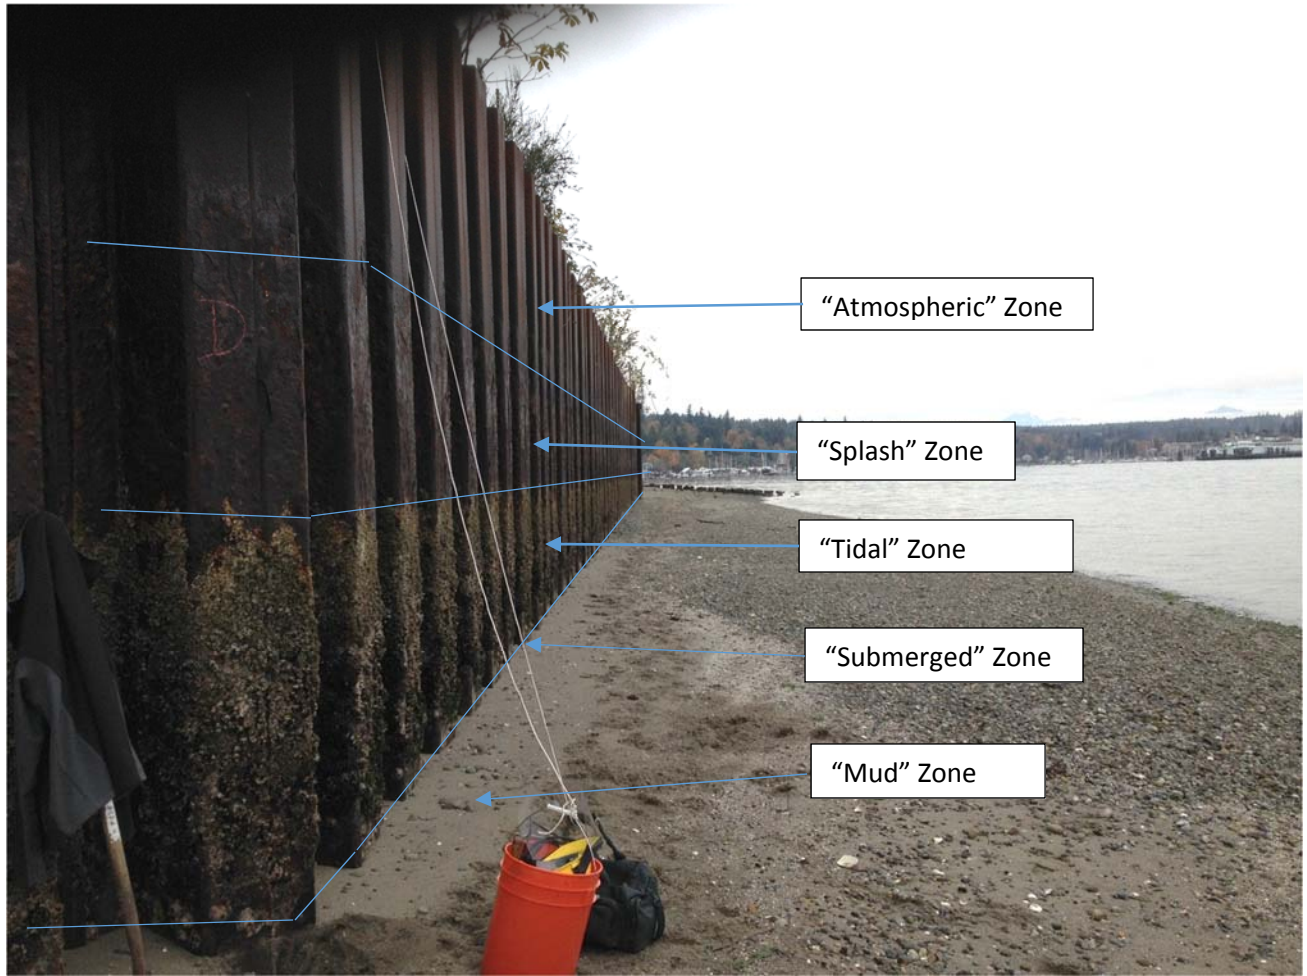
*Photograph 1.* General condition of the sheet pile wall in 2013, Wyckoff (Bainbridge Island), with exposure “zones” shown. North face.

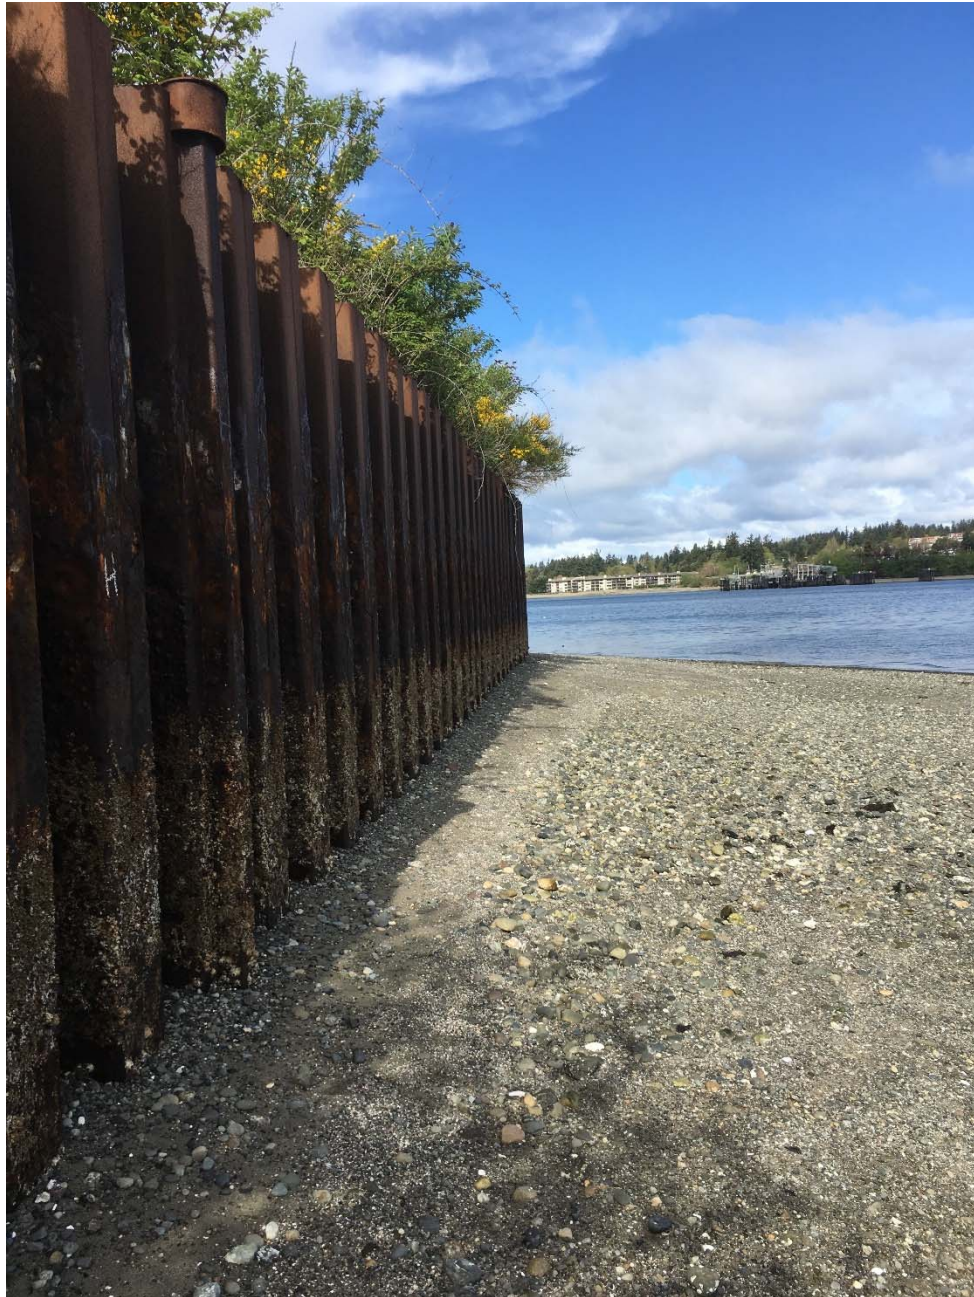
*Photograph 2. General condition of the sheet pile wall (north face) in 2017,*

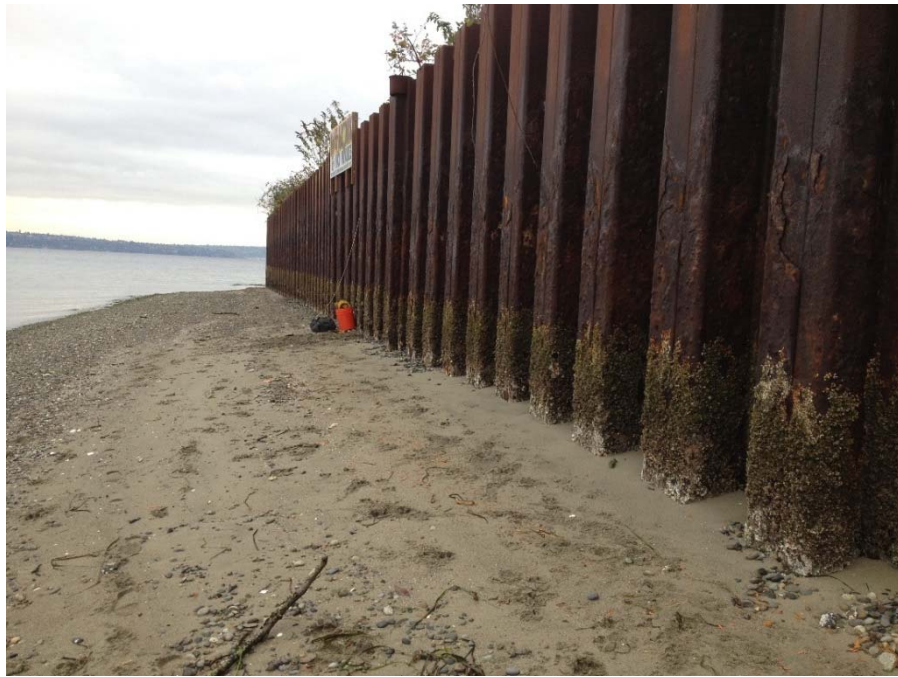
*Photograph 3.* General condition of sheet piling in 2013, northwest side of facility.

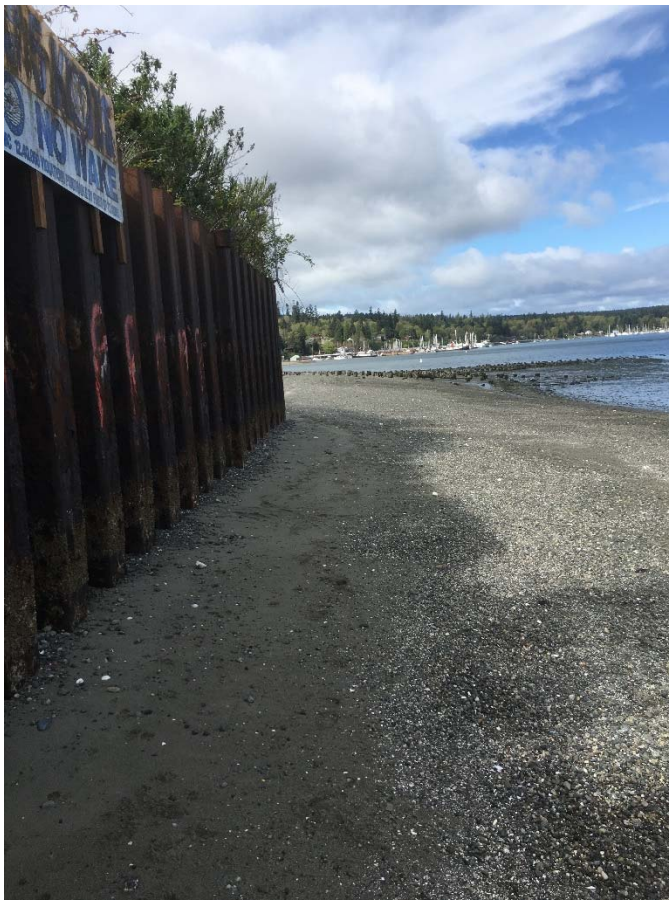
*Photograph 4.* General condition of sheet piling in 2013, northwest side of facility.

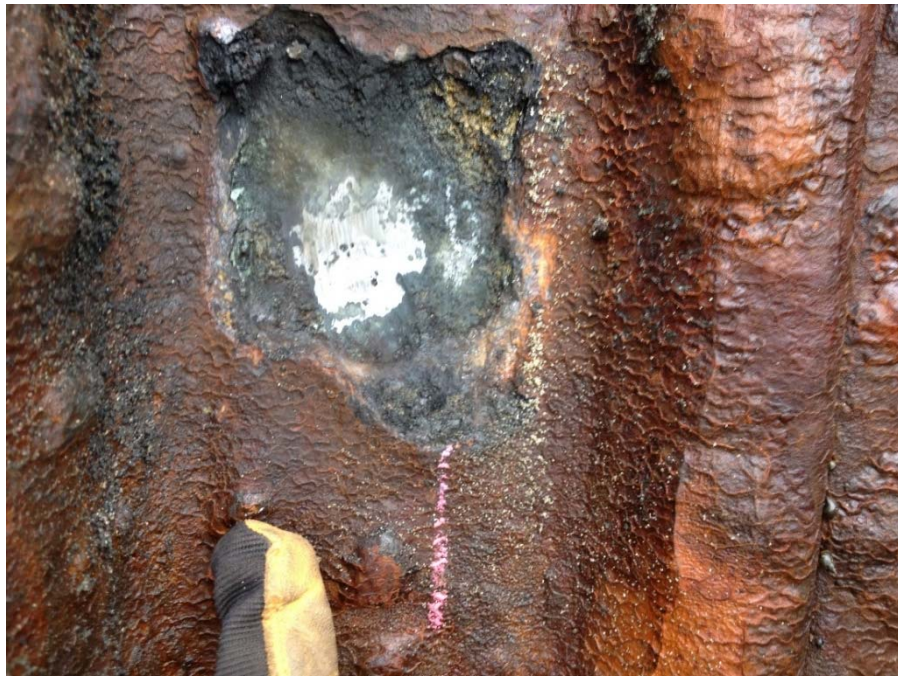
*Photograph 5.* Photograph illustrates the thickness and color of corrosion products in the “splash” zone (2013). Note the bright orange appearance on the surface, indicating active corrosion.

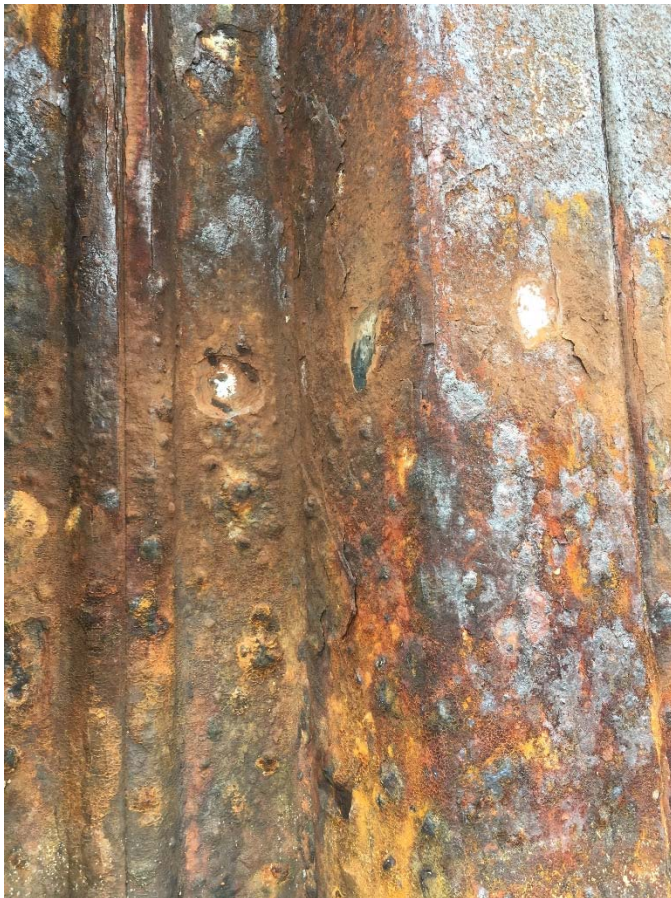
Heavy corrosion products are present in this zone. General metal loss and corrosion pitting is occurring. The effect of corrosion is more significant on the north side of the wall; the corrosion products have a different appearance in this area and deeper pits were observed.

*Photograph 6.* Appearance of the steel in the splash zone in 2017 was very similar to that observed in 2013.

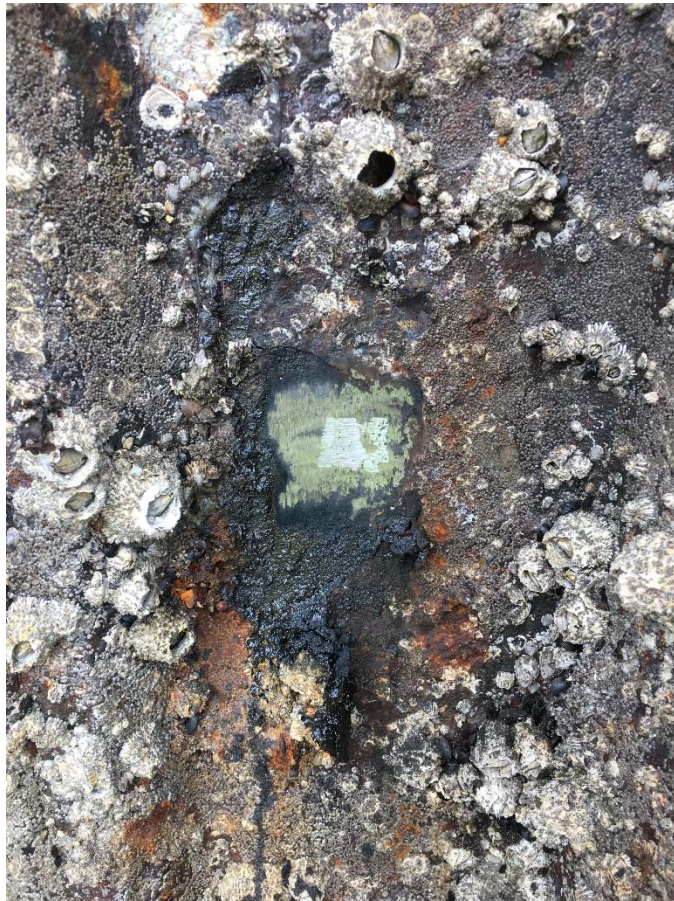
The “tidal” zone area exhibited more marine growth than the other zones. Moderately thick, tightly adhered corrosion products were found. Some pitting is occurring, but to a lesser extent than that observed in the “splash” zone.

*Photograph 7. Condition of sheet pile wall in the tidal zone (2017).*

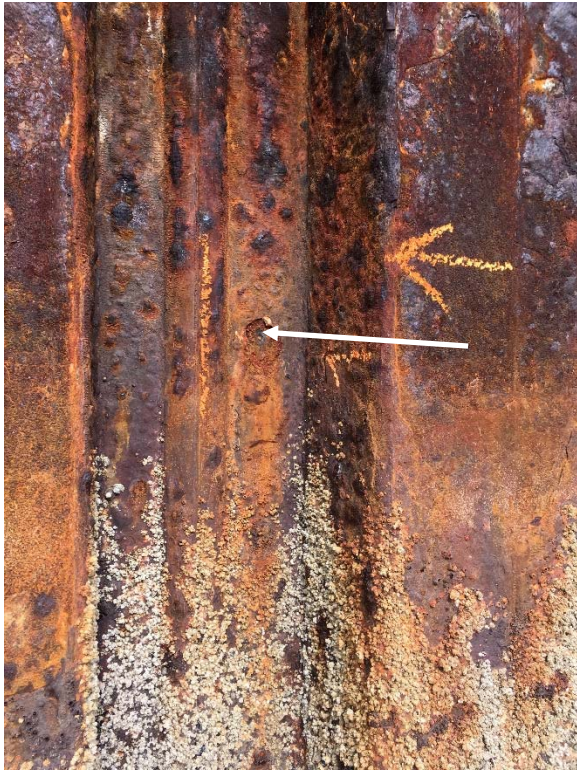
*Photograph 8.* <-- The white arrow shows the assumed location where corrosion products on the east wall were damaged by a thrown rock. Concern was voiced that the rock had penetrated the metal surface and soil fill behind the wall could be observed through a hole.

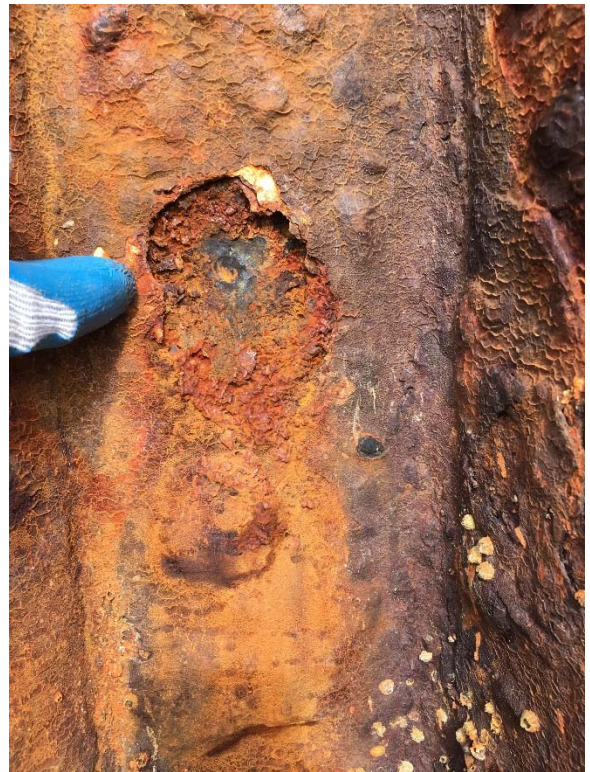
*Photograph 9.* → Close-up of corrosion product damaged by thrown rock. Although there appears to be soil-colored material in the damaged area, an intact metal surface is visible (dark gray material at center).

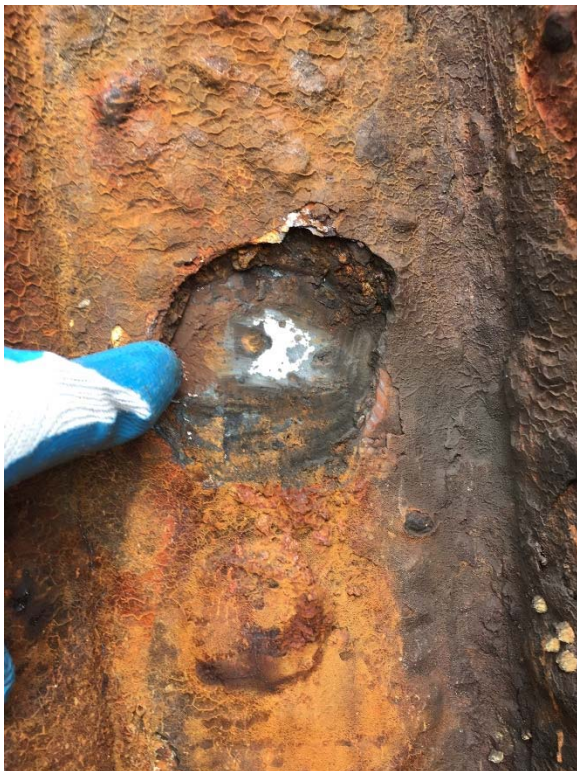
*Photograph 10.* <-- Corrosion product was removed from the surface. Pitting (localized corrosion) was observed, but it did not penetrate the sheet pile.

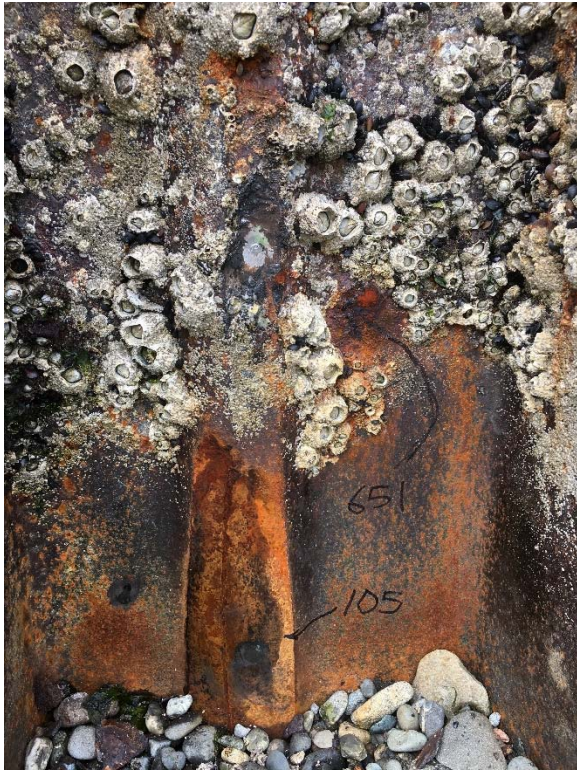
Although general corrosion rate of the flat surfaces of the piling was low in this zone, rapid deterioration was observed on the interlocks along the interior face of the piles. One interlock was found to have a remaining wall thickness of only 0.10”. See Photograph 11, attached.

Reference drawings show the interlock thickness to be approximately the same thickness as the flat surfaces of the interior face of the sheet. Therefore, the corrosion rate of the interlock is estimated to be as high as 35 mils per year  $([669 \text{ mils original} - 105 \text{ mils remaining} / 16 \text{ years}])$ . At this rate, penetration

of the interlocks could begin to occur within the next three to four years. Due to variations in corrosion noted on the interlocks along the sheet pile wall, there is possibly that some penetrations of the interlocks could occur within a year.

The cause of this rapid corrosion rate was not identified. Metal deterioration rates in this range are usually associated with bacteria, stray current, or abrasion. Rapid corrosion by stray current and bacteria are usually distributed along the entire surface and are not localized as observed on this wall. It appears that a more probable source of deterioration is abrasion due to concentrated wave effects (with suspended rocks and beach sand) at the interior pile interlock. There are some indications that deterioration of the interlocks was starting in 2013 (based on a review of previous photographs), but the deterioration was not nearly advanced as that observed in 2017. One possible reason for an increase in abrasion at this location is an increase in wave energy.

*Photograph 11.* <-- Significant deterioration of the interlock was observed at the "mud" line. Note that the surface is free of marine growth, and the rocky condition of the beach soil. The clean surface and localized corrosion of the interlock may be due to a combination of abrasion (erosion) and corrosion. Also note the metal thickness values written on the sheet pile (651 mils above the affected zone vs 105 mils at the affected area).

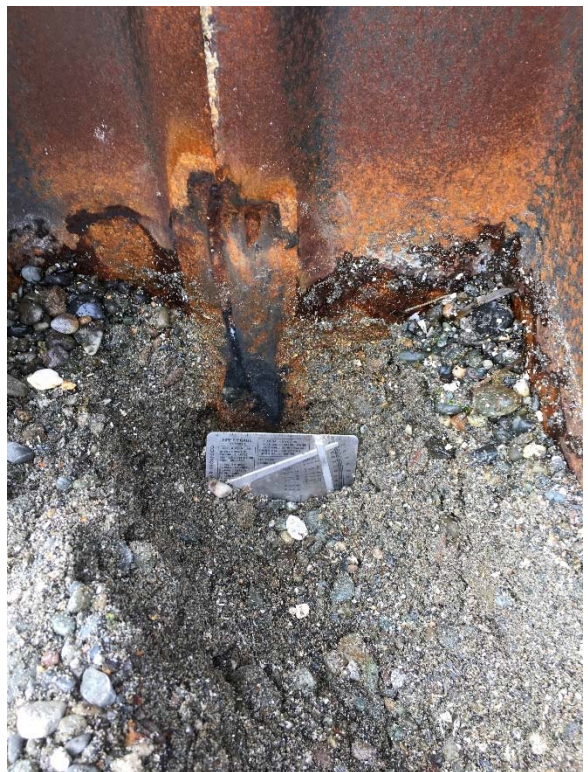
*Photograph 12.* → Some metal loss of the interlock due to corrosion is occurring below the "mud" line, but it is significantly less than the surface immediately above the "mud" line.

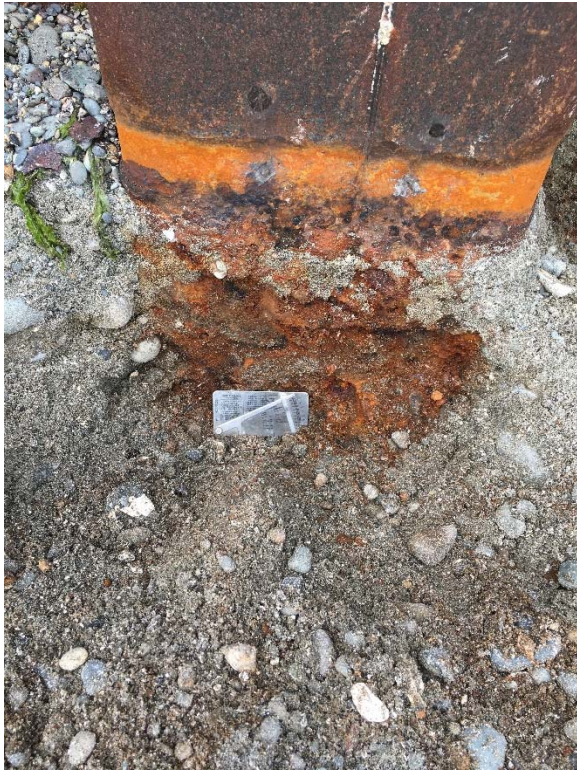
*Photograph 13.* <-- General condition of sheet pile below the "mud" line. The surfaces below the soil line are covered with relatively thick, tightly adhering corrosion products.

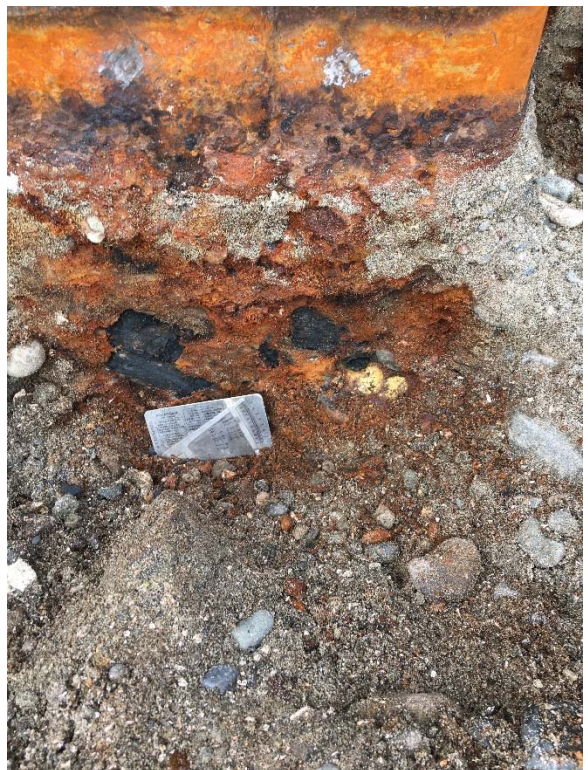
*Photograph 14.* → The metal surface below the soil line was in relatively good condition when the corrosion products were removed. The bright orange just above the mud line appears to be surface rust and may be associated with steel that is being abraded (exposing fresh steel). However, no significant metal loss was measured in either of these locations, and was less than the metal loss in the atmospheric, splash, and tidal zones.
